TECHNICAL BULLETIN

Number 1036

Subject: Upgrade of P-000-253 Rocker-Arm Lever to the New Style Lubrication Design of the P-022-558 Lever.

Engine models Affected: All six, eight, twelve and sixteen cylinder Superior 825 series gas engines.

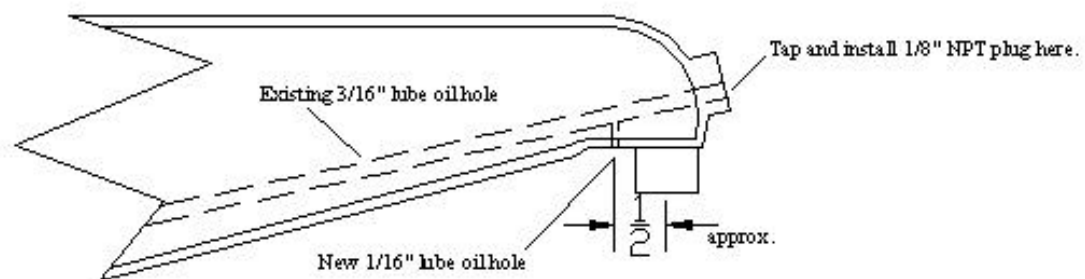
SOLUTION: To improve lubrication of the power valve stems, the following steps should be taken.

Drill a 1/16" hole approximately 1/2" from the center of the hardened tappet surface, through the bottom of the rocker lever. Drill until the 1/16" hole intersects the 3/16" hole that exists from the bushing bore through the end of the rocker lever.

Tap the existing 3/16" end hole, with a 1/8" NPT pipe tap.

Flush all machine debris and install a 1/8" pipe plug in the newly tapped threads. Apply a small amount of 242 Loctite or T271 Staybond to the threads.
